**Flood Control Project Maintenance
Levee Inspections****LMA District Cover Sheet****Spring 2014 Levee Inspection Results****American River Flood Control District**

Spring 2014 Levee Inspection Results

American River Flood Control District

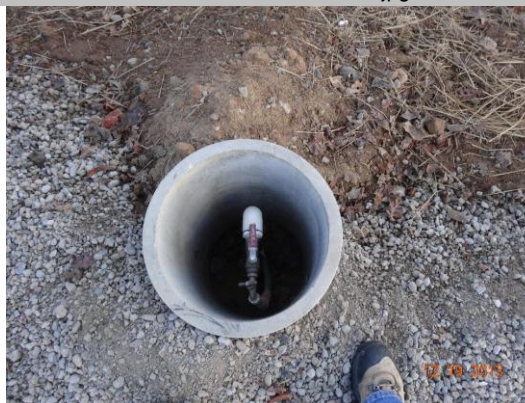
Photo 1 of 1 : UCIP_6422.jpg

LM Start	2.83	Rating **	M	Issue No.	215
LM End	2.83	Issue Type +	En	Location *	CR
Category	Supplemental			GPS Latitude/Longitude	
				Start	End
Item	DWR UCIP Field Study			38.587438 °	38.587438 °
				-121.464989 °	-121.464989 °
DWR ID	DWR_NA0001_04_s_2014_215				
Action/Comments					
Inspector Comments: FS_ID:31445					
EP_NO: N/A					
Repair Type:					
Crossing Status:					
UCIP Comments: No permit found (unauthorized?)--need additional information about crossing.					
FIELD_STRUCT_DESC: Standpipe located on waterward shoulder.					
Pipe crosses levee crown and landward side. Pipe used for irrigation.					
No Permit found.					
FS Date: 12/13/2013

Spigot located inside riser located on waterward shoulder.

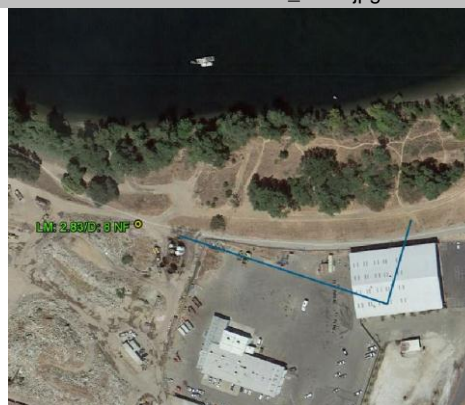
Photo 1 of 1 : UCIP_6367.jpg

Approximate alignment indicated in blue and approximate location indicated by DWR-UCIP in green label.

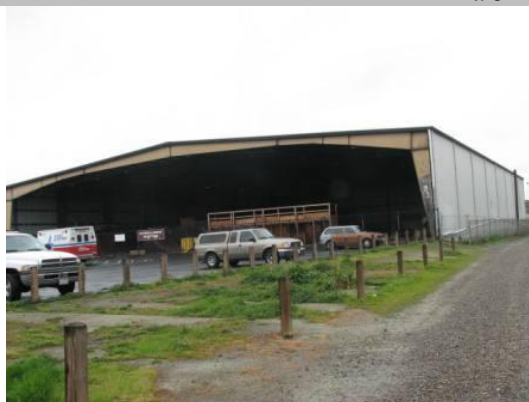
Photo 1 of 1 : mkhashch_s_20140428_00077.jpg

LM Start	2.92	Rating **	U	Issue No.	5
LM End	2.96	Issue Type +	En	Location *	LS
Category	Earthen Levee			GPS Latitude/Longitude	
				Start	End
Item	Encroachments			38.587251 °	38.587318 °
				-121.463237 °	-121.462513 °
DWR ID	DWR_NA0001_04_s _ 2012_5				
Action/Comments					
Building Inspector Comments: City of Sacramento building. Building is now Sutter's Landing Skate Park.

03/16/2012 Sutter's Landing Skate Park.

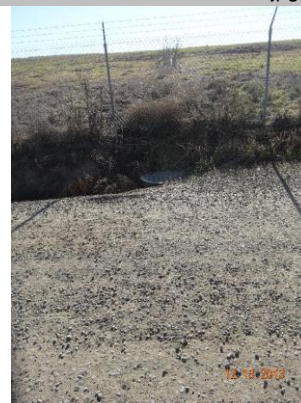
Photo 1 of 1 : UCIP_6371.jpg

UCIP Comments: Hole present on riser located on landward side--contact owner. Additional pipe found in waterward berm. Unable to confirm if this pipe section is part of crossing--size does not match. Unable to find CM standpipe on waterward side.

Riser located on landward side.

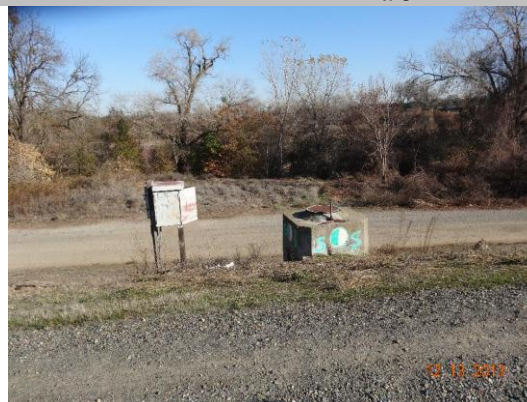
Photo 1 of 1 : UCIP_6374.jpg

LM Start	3.73	Rating **	M	Issue No.	219
LM End	3.73	Issue Type +	En	Location *	CR
Category	Supplemental			GPS Latitude/Longitude	
				Start	End
Item	DWR UCIP Field Study			38.587724 °	38.587724 °
				-121.449554 °	-121.449554 °
DWR ID	DWR_NA0001_04_s _ 2014_219				
Action/Comments					
Inspector Comments: FS_ID:31255					
EP_NO: N/A					
Repair Type:					
Crossing Status:					
UCIP Comments: Control box is non-functional parts have been removed. Unable to confirm diameter size and status--City of Sacramento incidates a 24 inch sewer main not 18 inch. Need to contact owner to confirm size.					
FIELD_STRUCT_DESC: 18-inch sewer main through the levee.					
Concrete manhole on the waterward slope.					
FS Date: 12/13/2013

View of waterward side.

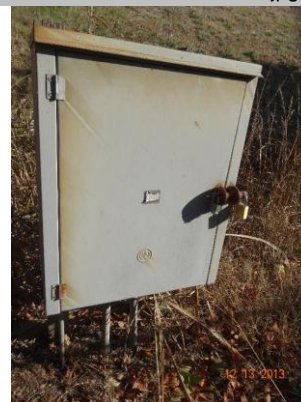
Photo 1 of 1 : UCIP_6195.jpg

LM Start	3.87	Rating **	M	Issue No.	221
LM End	3.87	Issue Type +	En	Location *	CR
Category	Supplemental			GPS Latitude/Longitude	
				Start	End
Item	DWR UCIP Field Study			38.586479 °	38.586479 °
				-121.447574 °	-121.447574 °
DWR ID	DWR_NA0001_04_s _ 2014_221				
Action/Comments					
Inspector Comments: FS_ID:29054					
EP_NO: N/A					
Repair Type:					
Crossing Status:					
UCIP Comments: Unknown owner--Need to coordinate with DWR Inspector and CVFPB.					
FIELD_STRUCT_DESC: 3-inch PVC conduit through levee, 2.0 feet below the crown.					
FS Date: 12/13/2013

Control box located on landward toe.

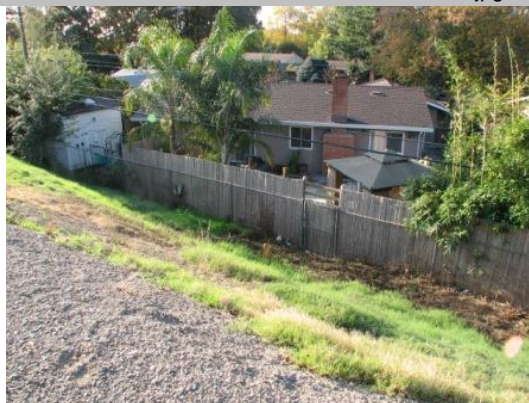
Photo 1 of 2 : mkhashch_s_20140428_00082.jpg

LM Start	3.88	Rating **	U	Issue No.	8
LM End	3.88	Issue Type +	En	Location *	LS
Category	Earthen Levee			GPS Latitude/Longitude	
				Start	End
Item	Encroachments			38.586327 °	38.586327 °
				-121.447373 °	-121.447373 °
DWR ID	DWR_NA0001_04_s _ 2012_8				
Action/Comments					
Fence					
Inspector Comments: Bamboo privacy fence within 10-ft of the landside toe obstructs visibility.

Fall 2009 photo: Fence and landscaping within 10-ft of levee toe obstructs access and visibility.

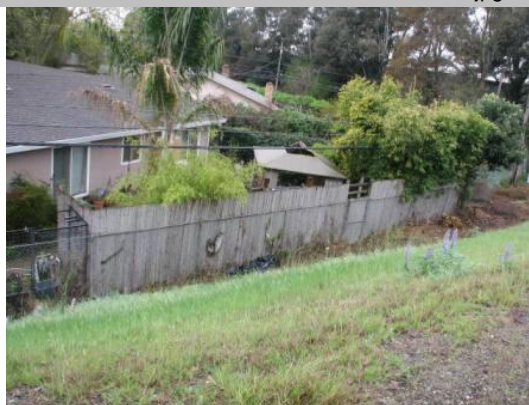
Photo 2 of 2 : mkhashch_s_20140428_00083.jpg

LM Start	3.88	Rating **	U	Issue No.	8 (cont)
LM End	3.88	Issue Type +	En	Location *	LS

03/16/2012 Wood privacy fence completely obstructs access and visibility.

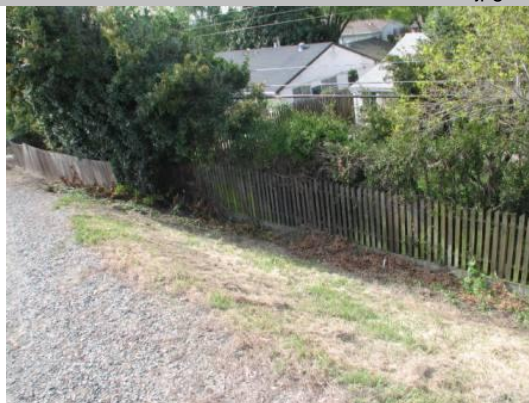
Photo 1 of 1 : mkhashch_s_20140428_00078.jpg

LM Start	3.90	Rating **	U	Issue No.	6
LM End	3.90	Issue Type +	En	Location *	LS
Category	Earthen Levee			GPS Latitude/Longitude	
				Start	End
Item	Encroachments			38.586154 °	38.586154 °
				-121.447115 °	-121.447115 °
DWR ID	DWR_NA0001_04_s_2012_6				
Action/Comments					
Fence

04/14/2011 Landscaping, which was a Fall inspection issue has been removed, however wooden fence is still obstructing access and visibility.

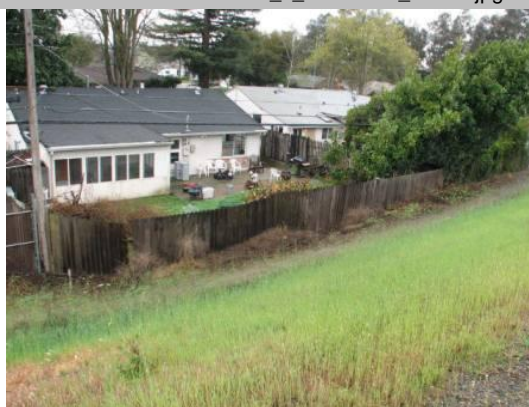
Photo 1 of 1 : mkhashch_s_20140428_00084.jpg

LM Start	3.91	Rating **	U	Issue No.	9
LM End	3.91	Issue Type +	En	Location *	LS
Category	Earthen Levee			GPS Latitude/Longitude	
				Start	End
Item	Encroachments			38.586047 °	38.586047 °
				-121.446975 °	-121.446975 °
DWR ID	DWR_NA0001_04_s_2012_9				
Action/Comments					
Fence					
Inspector Comments: Wooden privacy fence on the levee slope obstructs access and visibility.

03/16/2012 Wood privacy fence completely obstructs access and visibility.

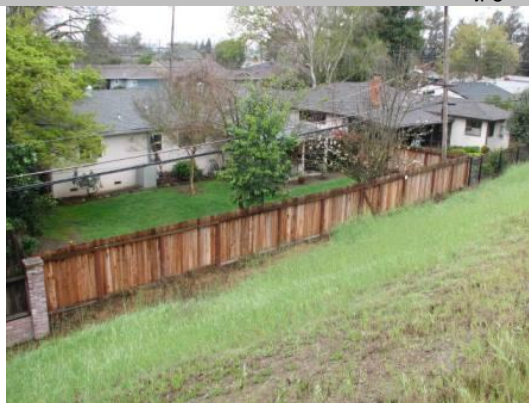
Photo 1 of 1 : mkhashch_s_20140428_00085.jpg

LM Start	3.95	Rating **	U	Issue No.	11
LM End	3.95	Issue Type +	En	Location *	LS
Category	Earthen Levee			GPS Latitude/Longitude	
				Start	End
Item	Encroachments			38.585639 °	38.585639 °
				-121.446451 °	-121.446451 °
DWR ID	DWR_NA0001_04_s _ 2012_11				
Action/Comments					
Fence					
Inspector Comments: Privacy fence and landscaping within 10-ft of the levee toe obstruct access and visibility.

03/16/2012 Wood privacy fence completely obstructs access and visibility.

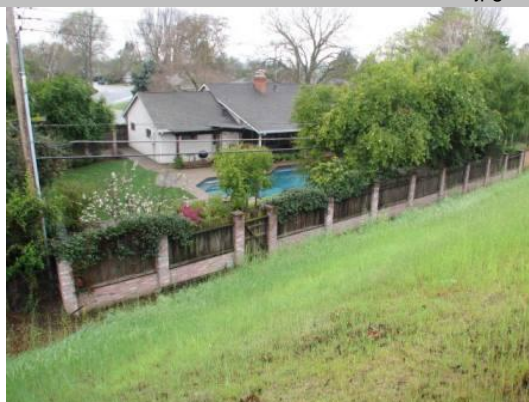
Photo 1 of 1 : mkhashch_s_20140428_00086.jpg

LM Start	3.96	Rating **	U	Issue No.	12
LM End	3.96	Issue Type +	En	Location *	LS
Category	Earthen Levee			GPS Latitude/Longitude	
				Start	End
Item	Encroachments			38.585496 °	38.585496 °
				-121.446309 °	-121.446309 °
DWR ID	DWR_NA0001_04_s _ 2012_12				
Action/Comments					
Fence					
Inspector Comments: Privacy fence and landscaping within 10-ft of the levee toe obstruct access and visibility.

03/16/2012 Wood privacy fence completely obstructs access and visibility.

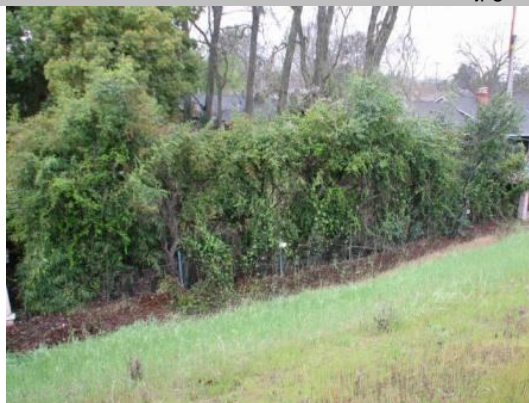
Photo 1 of 1 : mkhashch_s_20140428_00168.jpg

LM Start	3.97	Rating **	U	Issue No.	112
LM End	3.97	Issue Type +	En	Location *	LS
Category	Earthen Levee			GPS Latitude/Longitude	
				Start	End
Item	Vegetation			38.585385 °	38.585385 °
				-121.446168 °	-121.446168 °
DWR ID	DWR_NA0001_04_s _ 2012_112				
Action/Comments					
Landscaping					
Inspector Comments: Landscaping completely blocks visibility.

03/16/2012 Landscape obstructs visibility and access.

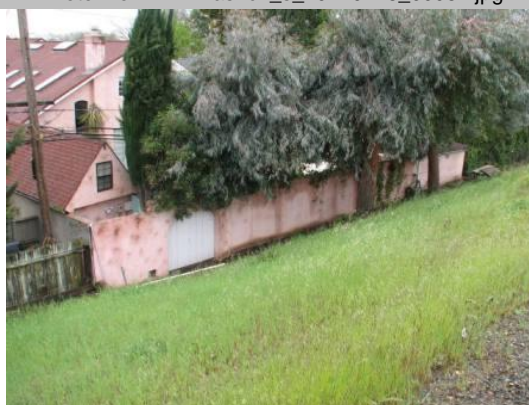
Photo 1 of 1 : mkhashch_s_20140428_00087.jpg

LM Start	3.98	Rating **	U	Issue No.	13
LM End	3.98	Issue Type +	En	Location *	LS
Category	Earthen Levee			GPS Latitude/Longitude	
				Start	End
Item	Encroachments			38.585325 °	38.585325 °
				-121.446059 °	-121.446059 °
DWR ID	DWR_NA0001_04_s _ 2012_13				
Action/Comments					
Fence					
Inspector Comments: Pink cement block fence obstructs access and visibility.

03/16/2012 Concrete wall obstructs access and visibility.

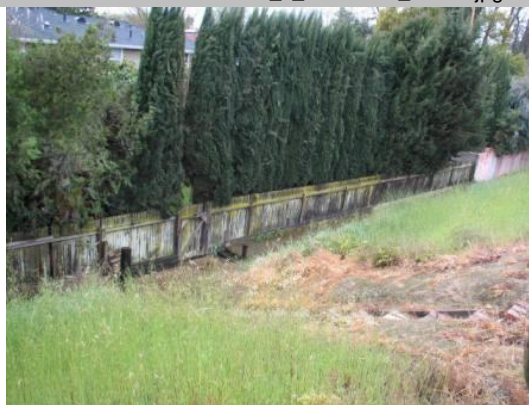
Photo 1 of 1 : mkhashch_s_20140428_00088.jpg

LM Start	4.00	Rating **	U	Issue No.	14
LM End	4.00	Issue Type +	En	Location *	LS
Category	Earthen Levee			GPS Latitude/Longitude	
				Start	End
Item	Encroachments			38.585175 °	38.585175 °
				-121.445883 °	-121.445883 °
DWR ID	DWR_NA0001_04_s _ 2012_14				
Action/Comments					
Fence					
Inspector Comments: Privacy fence and helix pencil shrubs planted within 10-ft of the levee toe obstruct access and visibility.

03/16/2012 Wood privacy fence completely obstructs access and visibility.

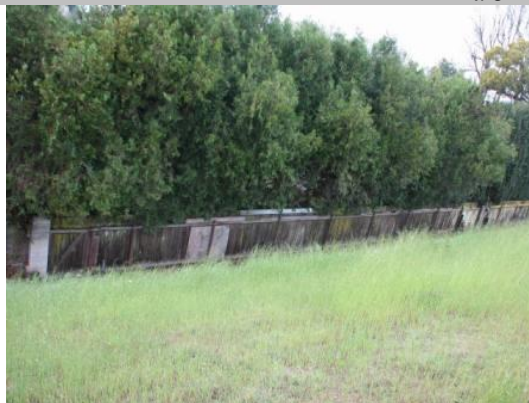
Photo 1 of 1 : mkhashch_s_20140428_00089.jpg

LM Start	4.01	Rating **	U	Issue No.	15
LM End	4.01	Issue Type +	En	Location *	LS
Category	Earthen Levee			GPS Latitude/Longitude	
				Start	End
Item	Encroachments			38.585021 °	38.585021 °
				-121.445678 °	-121.445678 °
DWR ID	DWR_NA0001_04_s _ 2012_15				
Action/Comments					
Fence					
Inspector Comments: Privacy fence and evergreen shrub landscaping within 10-ft of the levee toe obstruct access and visibility.

03/16/2012 Wood privacy fence completely obstructs access and visibility.

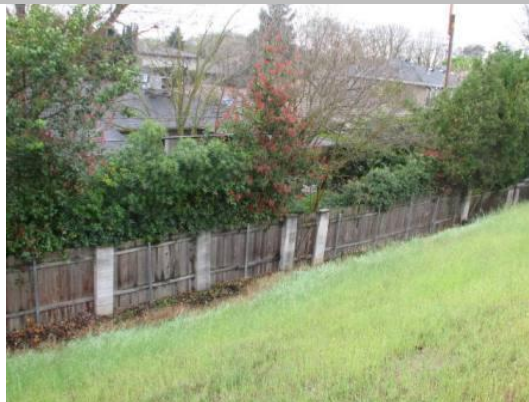
Photo 1 of 1 : mkhashch_s_20140428_00090.jpg

LM Start	4.02	Rating **	U	Issue No.	16
LM End	4.02	Issue Type +	En	Location *	LS
Category	Earthen Levee			GPS Latitude/Longitude	
				Start	End
Item	Encroachments			38.584885 °	38.584885 °
				-121.445520 °	-121.445520 °
DWR ID	DWR_NA0001_04_s _ 2012_16				
Action/Comments					
Fence					
Inspector Comments: Privacy fence and landscaping within 10-ft of the levee toe obstruct access and visibility.

03/16/2012 Wood privacy fence completely obstructs access and visibility.

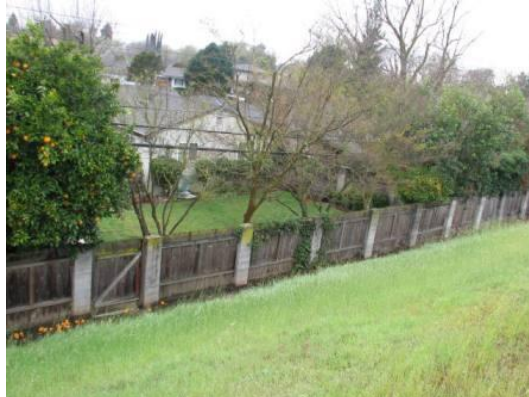
Photo 1 of 1 : mkhashch_s_20140428_00091.jpg

LM Start	4.03	Rating **	U	Issue No.	17
LM End	4.03	Issue Type +	En	Location *	LS
Category	Earthen Levee			GPS Latitude/Longitude	
				Start	End
Item	Encroachments			38.584810 °	38.584810 °
				-121.445403 °	-121.445403 °
DWR ID	DWR_NA0001_04_s _ 2012_17				
Action/Comments					
Fence					
Inspector Comments: Privacy fence and maple tree landscaping within 10-ft of the levee toe obstruct access and visibility.

03/16/2012 Wood privacy fence completely obstructs access and visibility.

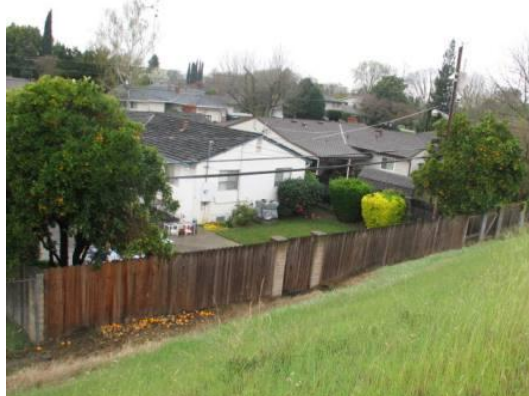
Photo 1 of 1 : mkhashch_s_20140428_00092.jpg

LM Start	4.04	Rating **	U	Issue No.	18
LM End	4.04	Issue Type +	En	Location *	LS
Category	Earthen Levee			GPS Latitude/Longitude	
				Start	End
Item	Encroachments			38.584694 °	38.584694 °
				-121.445255 °	-121.445255 °
DWR ID	DWR_NA0001_04_s _ 2012_18				
Action/Comments					
Fence Inspector Comments: Wooden fence between orange trees is within 10-ft of the levee toe.

03/16/2012 Wood privacy fence completely obstructs access and visibility.

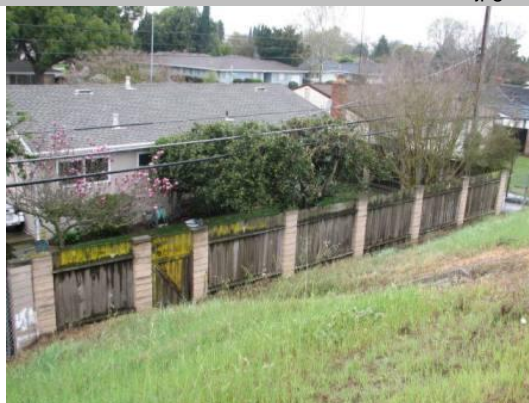
Photo 1 of 1 : mkhashch_s_20140428_00093.jpg

LM Start	4.07	Rating **	U	Issue No.	19
LM End	4.07	Issue Type +	En	Location *	LS
Category	Earthen Levee			GPS Latitude/Longitude	
				Start	End
Item	Encroachments			38.584459 °	38.584459 °
				-121.444951 °	-121.444951 °
DWR ID	DWR_NA0001_04_s _ 2012_19				
Action/Comments					
Fence Inspector Comments: Privacy fence within 10-ft of the levee toe obstruct access and visibility.

03/16/2012 Wood privacy fence completely obstructs access and visibility.

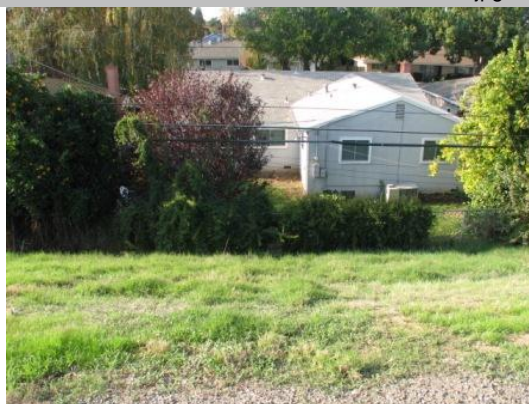
Photo 1 of 1 : mkhashch_s_20140428_00237.jpg

LM Start	4.08	Rating **	M	Issue No.	186
LM End	4.08	Issue Type +	En	Location *	LS
Category	Earthen Levee			GPS Latitude/Longitude	
				Start	End
Item	Vegetation			38.584354 °	38.584354 °
				-121.444792 °	-121.444792 °
DWR ID	DWR_NA0001_04_s _ 2012_186				
Action/Comments					
Landscaping Inspector Comments: Landscaping on cyclone fence within 10-ft of levee toe obstructs access and visibility.

Fall 2009 photo: Landscaping within 10-ft of levee toe obstructs access and visibility.

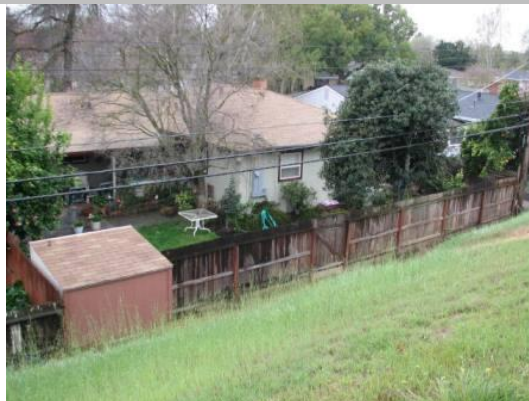
Photo 1 of 1 : mkhashch_s_20140428_00094.jpg

LM Start	4.09	Rating **	U	Issue No.	20
LM End	4.09	Issue Type +	En	Location *	LS
Category	Earthen Levee			GPS Latitude/Longitude	
				Start	End
Item	Encroachments			38.584243 °	38.584243 °
				-121.444647 °	-121.444647 °
DWR ID	DWR_NA0001_04_s _ 2012_20				
Action/Comments					
Fence					
Inspector Comments: Privacy fence and shed within 10-ft of the levee toe obstruct access and visibility.

03/16/2012 Wood privacy fence completely obstructs access and visibility.

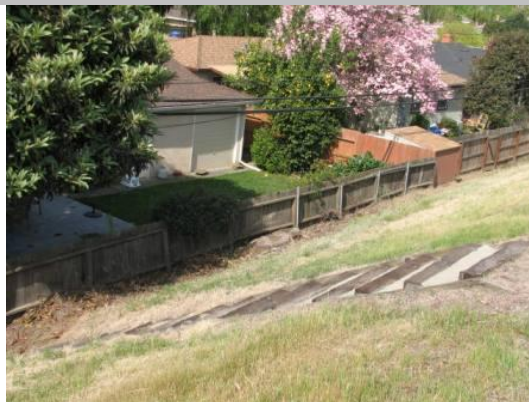
Photo 1 of 1 : mkhashch_s_20140428_00095.jpg

LM Start	4.10	Rating **	U	Issue No.	21
LM End	4.10	Issue Type +	En	Location *	LS
Category	Earthen Levee			GPS Latitude/Longitude	
				Start	End
Item	Vegetation			38.584129 °	38.584129 °
				-121.444485 °	-121.444485 °
DWR ID	DWR_NA0001_04_s _ 2012_21				
Action/Comments					
Landscaping Inspector Comments: Palms and other landscaping on levee slope, as well as the wooden privacy fence within 10-ft of the levee toe obstruct access and visibility. 04/14/2011 Palms have been removed.

04/14/2011 Palms have been removed.

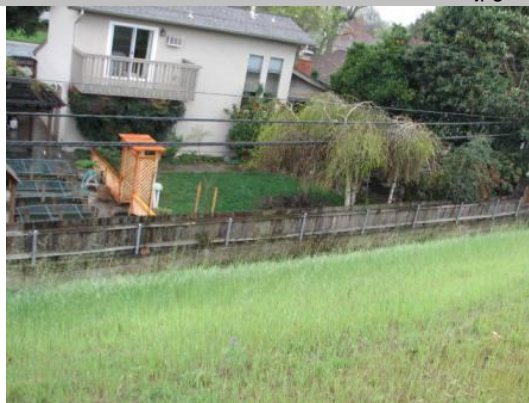
Photo 1 of 1 : mkhashch_s_20140428_00096.jpg

LM Start	4.11	Rating **	U	Issue No.	22
LM End	4.11	Issue Type +	En	Location *	LS
Category	Earthen Levee			GPS Latitude/Longitude	
				Start	End
Item	Encroachments			38.584034 °	38.584034 °
				-121.444322 °	-121.444322 °
DWR ID	DWR_NA0001_04_s _ 2012_22				
Action/Comments					
Fence					
Inspector Comments: Cement block and wooden fence as well as the landscape planting are within 10-ft of the levee slope and obstruct access and visibility.

03/16/2012 Wood privacy fence completely obstructs access and visibility.

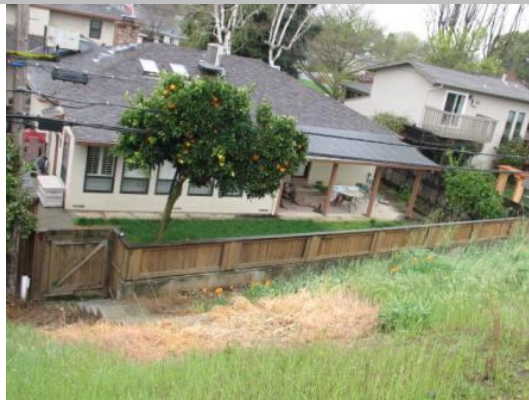
Photo 1 of 1 : mkhashch_s_20140428_00097.jpg

LM Start	4.12	Rating **	U	Issue No.	23
LM End	4.12	Issue Type +	En	Location *	LS
Category	Earthen Levee			GPS Latitude/Longitude	
				Start	End
Item	Encroachments			38.583935 °	38.583935 °
				-121.444150 °	-121.444150 °
DWR ID	DWR_NA0001_04_s _ 2012_23				
Action/Comments					
Fence					
Inspector Comments: Cement block and wooden fence obstruct visibility.

03/16/2012 Wooden fence on cement wall obstructs access and visibility.

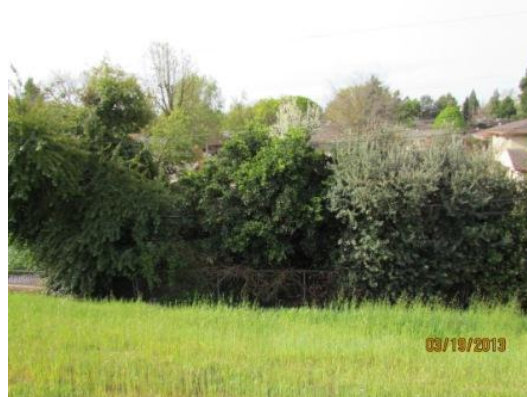
Photo 1 of 1 : mkhashch_s_20140428_00238.jpg

LM Start	4.13	Rating **	M	Issue No.	187
LM End	4.13	Issue Type +	En	Location *	LS
Category	Earthen Levee			GPS Latitude/Longitude	
				Start	End
Item	Vegetation			38.583858 °	38.583858 °
				-121.443981 °	-121.443981 °
DWR ID	DWR_NA0001_04_s _ 2012_187				
Action/Comments					
Landscaping Inspector Comments: Orange, guava and other trees and landscaping obstruct access and visibility.

View of the obstructing vegetation at levee toe.

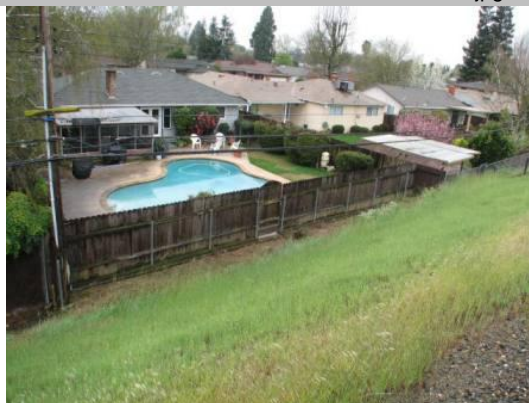
Photo 1 of 1 : mkhashch_s_20140428_00239.jpg

LM Start	4.17	Rating **	U	Issue No.	190
LM End	4.17	Issue Type +	En	Location *	LS
Category	Earthen Levee			GPS Latitude/Longitude	
				Start	End
Item	Vegetation			38.583559 °	38.583559 °
				-121.443485 °	-121.443485 °
DWR ID	DWR_NA0001_04_s _ 2012_190				
Action/Comments					
Landscaping Inspector Comments: Planter boxes built into levee slope. Wooden fence obstructs visibility. Pool is just outside 10-ft from levee toe.

03/16/2012 Wood privacy fence completely obstructs access and visibility.

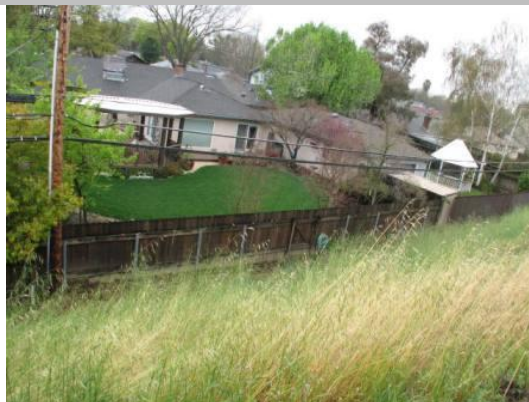
Photo 1 of 1 : mkhashch_s_20140428_00240.jpg

LM Start	4.19	Rating **	U	Issue No.	191
LM End	4.19	Issue Type +	En	Location *	LS
Category	Earthen Levee			GPS Latitude/Longitude	
				Start	End
Item	Encroachments			38.583355 °	38.583355 °
				-121.443123 °	-121.443123 °
DWR ID	DWR_NA0001_04_s _ 2012_191				
Action/Comments					
Fence Inspector Comments: Wooden privacy fence within 10-ft of the levee toe obstruct access and visibility.

03/16/2012 Wood privacy fence completely obstructs access and visibility.

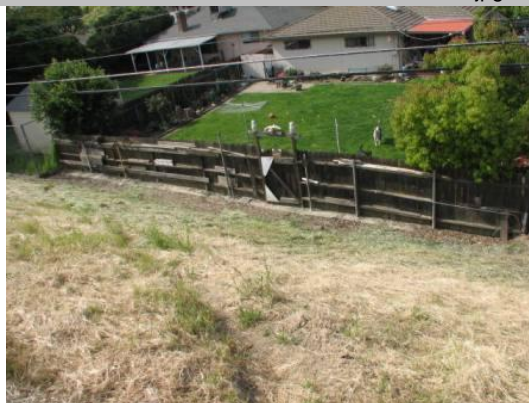
Photo 1 of 1 : mkhashch_s_20140428_00098.jpg

LM Start	4.21	Rating **	U	Issue No.	24
LM End	4.21	Issue Type +	En	Location *	LS
Category	Earthen Levee			GPS Latitude/Longitude	
				Start	End
Item	Encroachments			38.583265 °	38.583265 °
				-121.442965 °	-121.442965 °
DWR ID	DWR_NA0001_04_s_2012_24				
Action/Comments					
Fence					
Inspector Comments: Wooden privacy fence obstructs visibility.					
Retaining wall built into levee toe. 04/14/2011 retaining wall removed.

04/14/2011 Retaining wall has been removed. Wooden fence remains and is obstructing access and visibility.

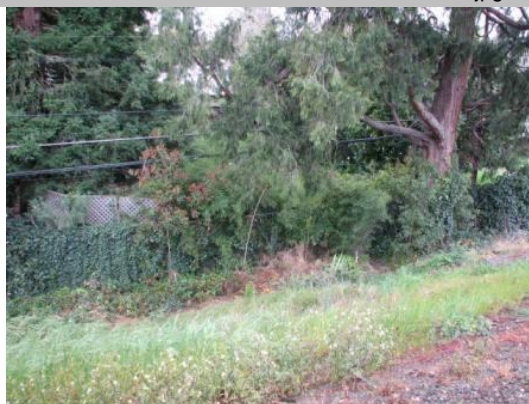
Photo 1 of 1 : mkhashch_s_20140428_00241.jpg

LM Start	4.23	Rating **	U	Issue No.	192
LM End	4.23	Issue Type +	En	Location *	LS
Category	Earthen Levee			GPS Latitude/Longitude	
				Start	End
Item	Vegetation			38.583031 °	38.583031 °
				-121.442620 °	-121.442620 °
DWR ID	DWR_NA0001_04_s_2012_192				
Action/Comments					
Landscaping Inspector Comments: Ivy and vine growth on cyclone fence obstruct visibility. Steps and landscaping built up levee slope.

03/16/2012 Landscaping on fence obstructs visibility and access.

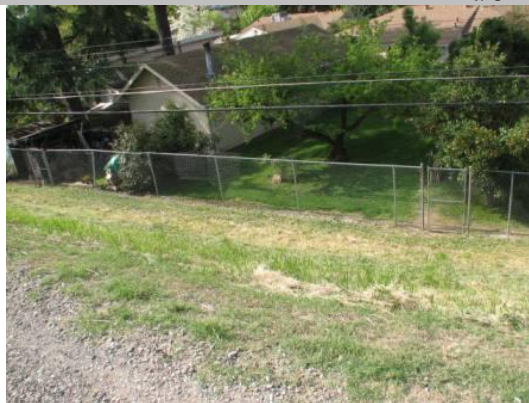
Photo 1 of 1 : mkhashch_s_20140428_00242.jpg

LM Start	4.27	Rating **	M	Issue No.	194
LM End	4.27	Issue Type +	En	Location *	LS
Category	Earthen Levee			GPS Latitude/Longitude	
				Start	End
Item	Encroachments			38.582716 °	38.582716 °
				-121.442128 °	-121.442128 °
DWR ID	DWR_NA0001_04_s_2012_194				
Action/Comments					
Fence Inspector Comments: Planting boxes built into levee slope. 04/14/2011 Planter boxes removed. Chainlink fence partially obstructs access.

04/14/2011 Planter boxes have been removed. Chainlink fence partially blocks access.

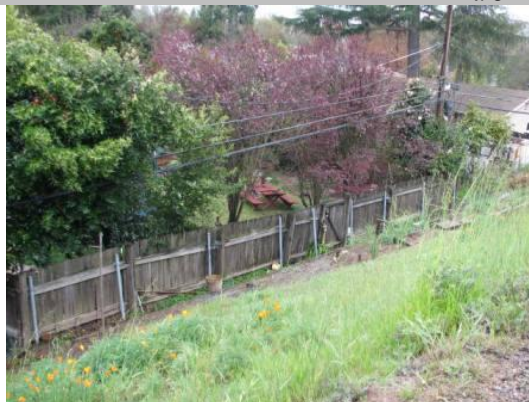
Photo 1 of 1 : mkhashch_s_20140428_00100.jpg

LM Start	4.29	Rating **	U	Issue No.	26
LM End	4.29	Issue Type +	En	Location *	LS
Category	Earthen Levee			GPS Latitude/Longitude	
				Start	End
Item	Encroachments			38.582479 °	38.582479 °
				-121.441768 °	-121.441768 °
DWR ID	DWR_NA0001_04_s_2012_26				
Action/Comments					
Fence					
Inspector Comments: Wooden fence within 10-ft of the levee toe.					
Garden and ramp built on levee slope.

03/16/2012 Wood privacy fence completely obstructs access and visibility.

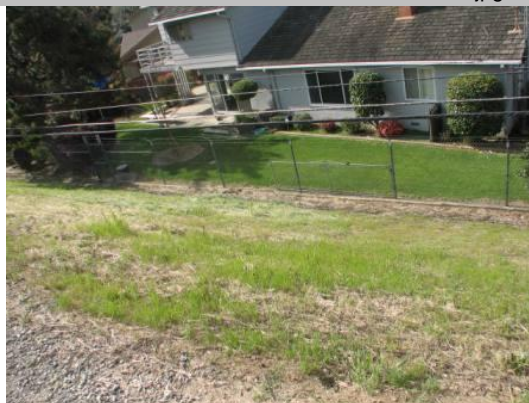
Photo 1 of 1 : mkhashch_s_20140428_00243.jpg

LM Start	4.31	Rating **	M	Issue No.	195
LM End	4.31	Issue Type +	En	Location *	LS
Category	Earthen Levee			GPS Latitude/Longitude	
				Start	End
Item	Encroachments			38.582333 °	38.582333 °
				-121.441506 °	-121.441506 °
DWR ID	DWR_NA0001_04_s _ 2012_195				
Action/Comments					
Fence					
Inspector Comments: Landscaping planted on levee slope. 04/14/2011					
Landscaping removed, chainlink fence remains.

04/14/2011 Landscape removed, chainlink fence remains.

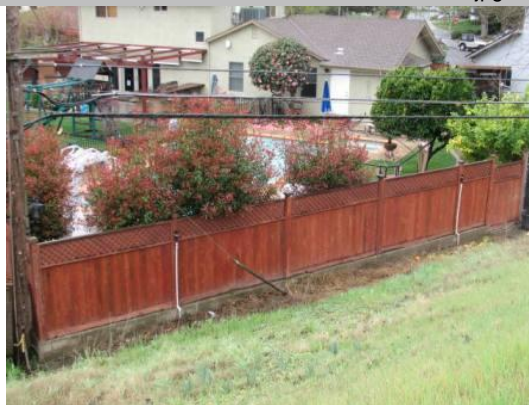
Photo 1 of 1 : mkhashch_s_20140428_00101.jpg

LM Start	4.33	Rating **	U	Issue No.	27
LM End	4.33	Issue Type +	En	Location *	LS
Category	Earthen Levee			GPS Latitude/Longitude	
				Start	End
Item	Encroachments			38.582223 °	38.582223 °
				-121.441264 °	-121.441264 °
DWR ID	DWR_NA0001_04_s _ 2012_27				
Action/Comments					
Fence					
Inspector Comments: Wooden privacy fence obstructs visibility.

03/16/2012 Wood privacy fence completely obstructs access and visibility.

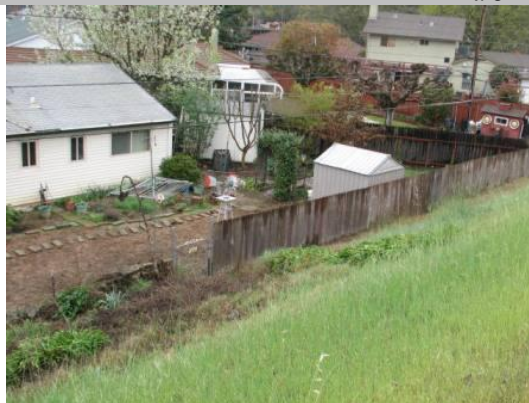
Photo 1 of 1 : mkhashch_s_20140428_00103.jpg

LM Start	4.35	Rating **	M	Issue No.	29
LM End	4.35	Issue Type +	En	Location *	LS
Category	Earthen Levee			GPS Latitude/Longitude	
				Start	End
Item	Encroachments			38.582083 °	38.582083 °
				-121.440875 °	-121.440875 °
DWR ID	DWR_NA0001_04_s _ 2012_29				
Action/Comments					
Fence					
Inspector Comments: Large flowering bush on levee slope - removed by ARFCD 2012. Retaining wall removed by ARFCD 2012. Wooden fence located at the levee toe obstructs access and visibility. 04/14/2011

03/16/2012 Flowering bush is dormant, landscaping on levee slope and wooden privacy fence.

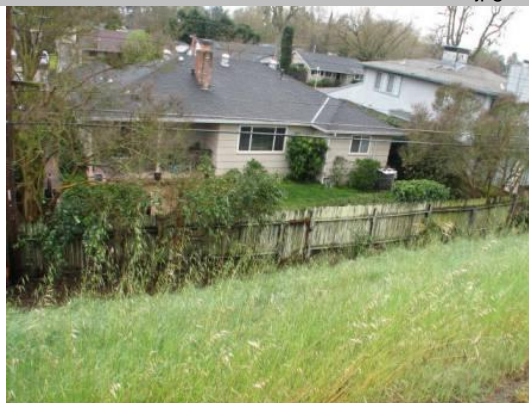
Photo 1 of 1 : mkhashch_s_20140428_00244.jpg

LM Start	4.40	Rating **	U	Issue No.	198
LM End	4.40	Issue Type +	En	Location *	LS
Category	Earthen Levee			GPS Latitude/Longitude	
				Start	End
Item	Encroachments			38.581788 °	38.581788 °
				-121.440086 °	-121.440086 °
DWR ID	DWR_NA0001_04_s _ 2012_198				
Action/Comments					
Fence					
Inspector Comments: Privacy fence and landscaping within 10-ft of the levee toe obstruct access and visibility.

03/16/2012 Wood privacy fence completely obstructs access and visibility.

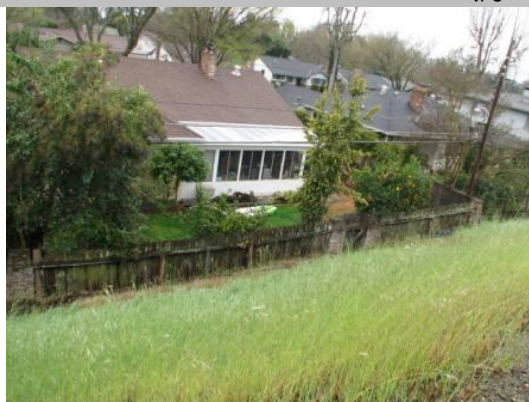
Photo 1 of 1 : mkhashch_s_20140428_00104.jpg

LM Start	4.41	Rating **	U	Issue No.	30
LM End	4.41	Issue Type +	En	Location *	LS
Category	Earthen Levee			GPS Latitude/Longitude	
				Start	End
Item	Encroachments			38.581724 °	38.581724 °
				-121.439891 °	-121.439891 °
DWR ID	DWR_NA0001_04_s _ 2012_30				
Action/Comments					
Fence					
Inspector Comments: Privacy fence and landscaping within 10-ft of the levee toe obstruct access and visibility.

03/16/2012 Wood privacy fence completely obstructs access and visibility.

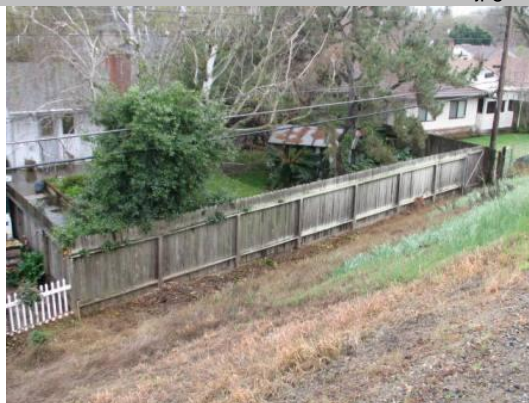
Photo 1 of 1 : mkhashch_s_20140428_00105.jpg

LM Start	4.45	Rating **	U	Issue No.	31
LM End	4.45	Issue Type +	En	Location *	LS
Category	Earthen Levee			GPS Latitude/Longitude	
				Start	End
Item	Encroachments			38.581495 °	38.581495 °
				-121.439129 °	-121.439129 °
DWR ID	DWR_NA0001_04_s _ 2012_31				
Action/Comments					
Fence					
Inspector Comments: Privacy fence within 10-ft of the levee toe obstructs access and visibility.

03/16/2012 Wood privacy fence completely obstructs access and visibility.

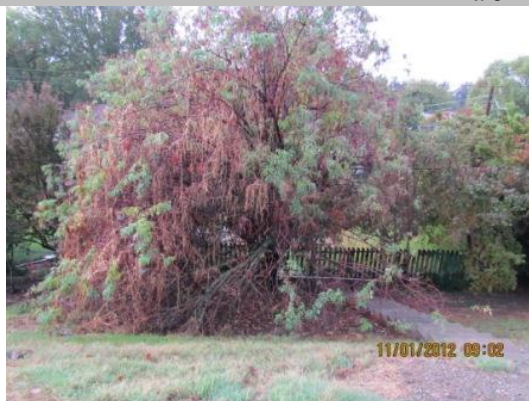
Photo 1 of 1 : mkhashch_s_20140428_00264.jpg

LM Start	4.50	Rating **	M	Issue No.	253
LM End	4.50	Issue Type +	Ma	Location *	WS
Category	Earthen Levee			GPS Latitude/Longitude	
				Start	End
Item	Vegetation			38.581320 °	38.581320 °
				-121.438263 °	-121.438263 °
DWR ID	DWR_NA0001_04_s _ 2012_253				
Action/Comments					
Elderberries are blocking visibility and flood fight capability.

View of large elderberry bush obstructing visibility and access.

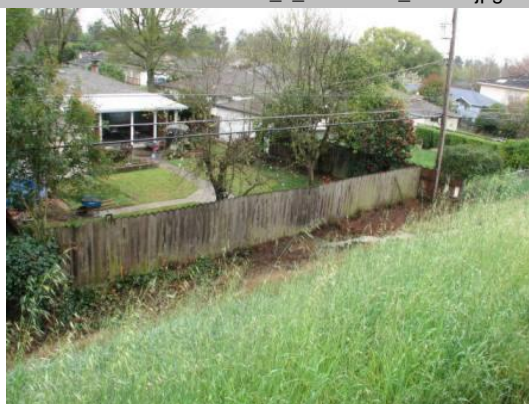
Photo 1 of 1 : mkhashch_s_20140428_00106.jpg

LM Start	4.52	Rating **	U	Issue No.	35
LM End	4.52	Issue Type +	En	Location *	LS
Category	Earthen Levee			GPS Latitude/Longitude	
				Start	End
Item	Encroachments			38.581246 °	38.581246 °
				-121.438033 °	-121.438033 °
DWR ID	DWR_NA0001_04_s _ 2012_35				
Action/Comments					
Fence					
Inspector Comments: Wooden fence within 10-ft of the levee toe obstructs access and visibility.

03/16/2012 Wood privacy fence completely obstructs access and visibility.

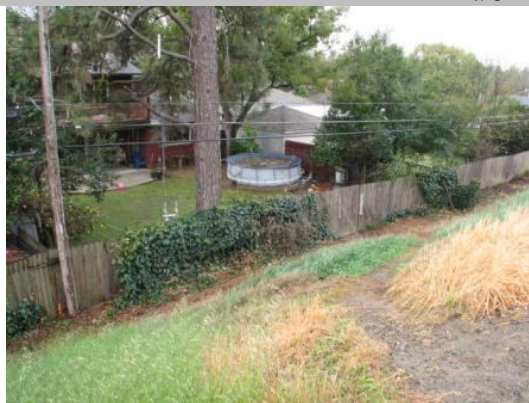
Photo 1 of 1 : mkhashch_s_20140428_00245.jpg

LM Start	4.53	Rating **	U	Issue No.	199
LM End	4.53	Issue Type +	En	Location *	LS
Category	Earthen Levee			GPS Latitude/Longitude	
				Start	End
Item	Encroachments			38.581205 °	38.581205 °
				-121.437830 °	-121.437830 °
DWR ID	DWR_NA0001_04_s _ 2012_199				
Action/Comments					
Fence					
Inspector Comments: Wooden fence is within 10-ft of the levee toe.

03/16/2012 Wood privacy fence completely obstructs access and visibility.

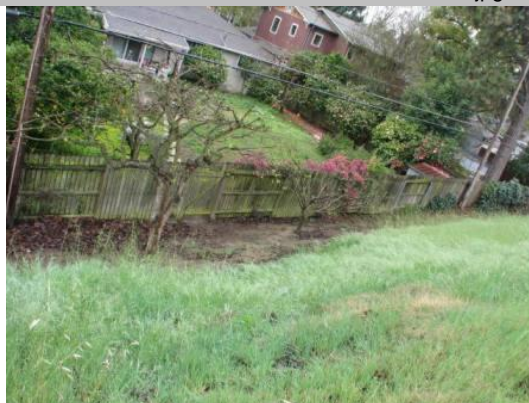
Photo 1 of 1 : mkhashch_s_20140428_00246.jpg

LM Start	4.54	Rating **	U	Issue No.	200
LM End	4.54	Issue Type +	En	Location *	LS
Category	Earthen Levee			GPS Latitude/Longitude	
				Start	End
Item	Encroachments			38.581178 °	38.581178 °
				-121.437584 °	-121.437584 °
DWR ID	DWR_NA0001_04_s _ 2012_200				
Action/Comments					
Fence					
Inspector Comments: Privacy fence, persimmon tree and landscaping within 10-ft of the levee toe obstruct access and visibility.

03/16/2012 Wood privacy fence completely obstructs access and visibility.

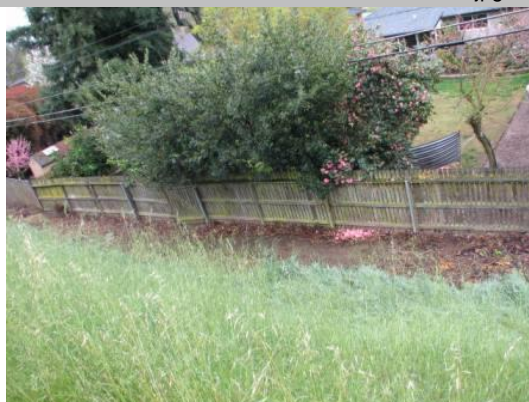
Photo 1 of 1 : mkhashch_s_20140428_00247.jpg

LM Start	4.55	Rating **	U	Issue No.	201
LM End	4.55	Issue Type +	En	Location *	LS
Category	Earthen Levee			GPS Latitude/Longitude	
				Start	End
Item	Encroachments			38.581155 °	38.581155 °
				-121.437320 °	-121.437320 °
DWR ID	DWR_NA0001_04_s _ 2012_201				
Action/Comments					
Fence					
Inspector Comments: Privacy fence within 10-ft of the levee toe obstruct access and visibility.

03/16/2012 Wood privacy fence completely obstructs access and visibility.

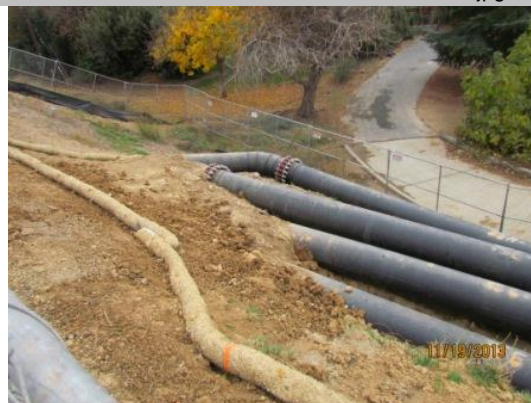
Photo 1 of 1 : mkhashch_s_20140428_00250.jpg

LM Start	4.60	Rating **	U	Issue No.	204
LM End	4.60	Issue Type +	En	Location *	CR
Category	Earthen Levee			GPS Latitude/Longitude	
				Start	End
Item	Encroachments			38.581089 °	38.581089 °
				-121.436472 °	-121.436472 °
DWR ID	DWR_NA0001_04_f_2013_204				
Action/Comments					
Pipe Inspector Comments: Temporary pipes crossing the levee as part of USACE slurry wall project.

View of the temporary pipes penetrating the landside levee slope.

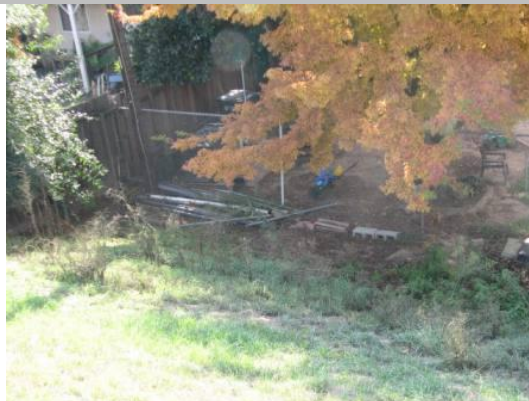
Photo 1 of 2 : mkhashch_s_20140428_00265.jpg

LM Start	4.72	Rating **	M	Issue No.	739
LM End	4.72	Issue Type +	En	Location *	LS
Category	Earthen Levee			GPS Latitude/Longitude	
				Start	End
Item	Encroachments			38.580778 °	38.580778 °
				-121.434467 °	-121.434467 °
DWR ID	DWR_NA0001_04_s _ 2012_739				
Action/Comments					
Debris					
Inspector Comments: PVC pipe and debris, also noted in USACE PI.

11/15/2011 Debris on levee side of fence. This item was noted in the USACE PI.

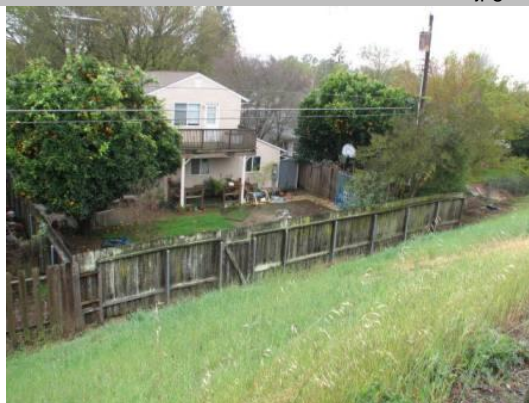
Photo 1 of 1 : mkhashch_s_20140428_00107.jpg

LM Start	4.73	Rating **	U	Issue No.	40
LM End	4.73	Issue Type +	En	Location *	LS
Category	Earthen Levee			GPS Latitude/Longitude	
				Start	End
Item	Encroachments			38.580759 °	38.580759 °
				-121.434294 °	-121.434294 °
DWR ID	DWR_NA0001_04_s _ 2012_40				
Action/Comments					
Fence

03/16/2012 Wood privacy fence completely obstructs access and visibility.

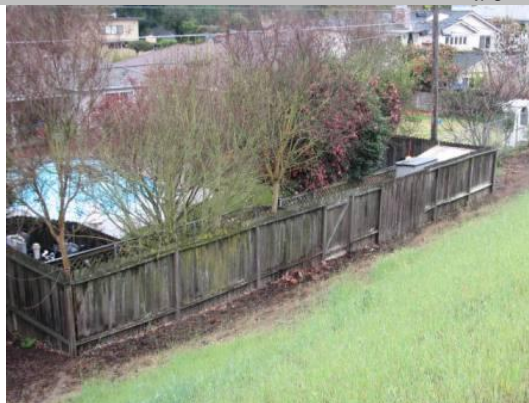
Photo 1 of 1 : mkhashch_s_20140428_00109.jpg

LM Start	4.77	Rating **	U	Issue No.	43
LM End	4.77	Issue Type +	En	Location *	LS
Category	Earthen Levee			GPS Latitude/Longitude	
				Start	End
Item	Encroachments			38.580731 °	38.580731 °
				-121.433490 °	-121.433490 °
DWR ID	DWR_NA0001_04_s _ 2012_43				
Action/Comments					
Fence					
Inspector Comments: Privacy fence and storage sheds within 10-ft of the levee toe obstruct access and visibility.

03/16/2012 Wood privacy fence completely obstructs access and visibility.

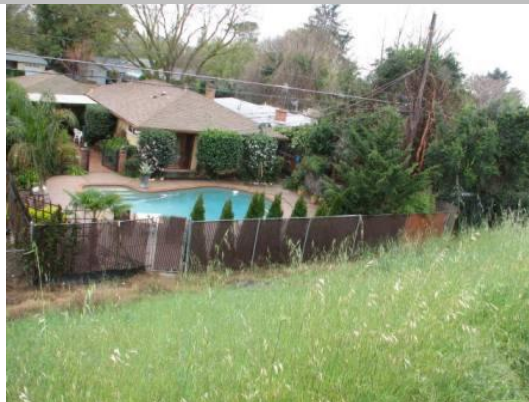
Photo 1 of 1 : mkhashch_s_20140428_00251.jpg

LM Start	4.82	Rating **	U	Issue No.	205
LM End	4.82	Issue Type +	En	Location *	LS
Category	Earthen Levee			GPS Latitude/Longitude	
				Start	End
Item	Encroachments			38.580723 °	38.580723 °
				-121.432577 °	-121.432577 °
DWR ID	DWR_NA0001_04_s _ 2012_205				
Action/Comments					
Fence					
Inspector Comments: Privacy fence and landscape prunings on levee slope and toe.prunings removed. Fence obstructs access and visibility.

03/16/2012 Chainlink fence with privacy slats obstructs visibility and access.

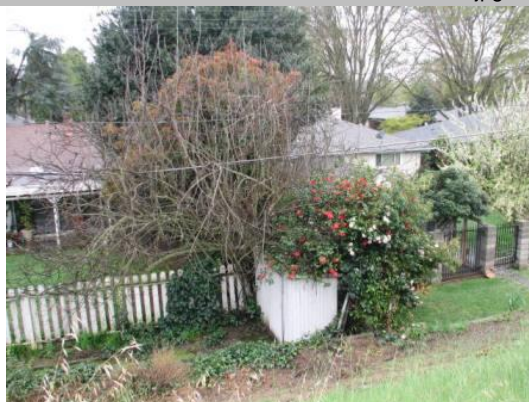
Photo 1 of 1 : mkhashch_s_20140428_00252.jpg

LM Start	4.87	Rating **	U	Issue No.	206
LM End	4.87	Issue Type +	En	Location *	LS
Category	Earthen Levee			GPS Latitude/Longitude	
				Start	End
Item	Vegetation			38.580778 °	38.580778 °
				-121.431704 °	-121.431704 °
DWR ID	DWR_NA0001_04_s _ 2012_206				
Action/Comments					
Landscaping					
Inspector Comments: Fig tree obstructs visibility and access.

03/16/2012 Landscaping obstructs visibility and access.

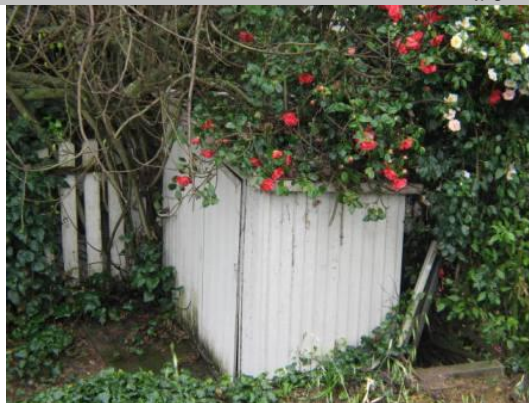
Photo 1 of 1 : mkhashch_s_20140428_00152.jpg

LM Start	4.87	Rating **	U	Issue No.	96
LM End	4.87	Issue Type +	En	Location *	LS
Category	Earthen Levee			GPS Latitude/Longitude	
				Start	End
Item	Encroachments			38.580767 °	38.580767 °
				-121.431684 °	-121.431684 °
DWR ID	DWR_NA0001_04_s _ 2012_96				
Action/Comments					
Building					
Inspector Comments: Wooden shed is located beneath the fig tree.

3/16/2012 Structure is within 15' of levee toe.

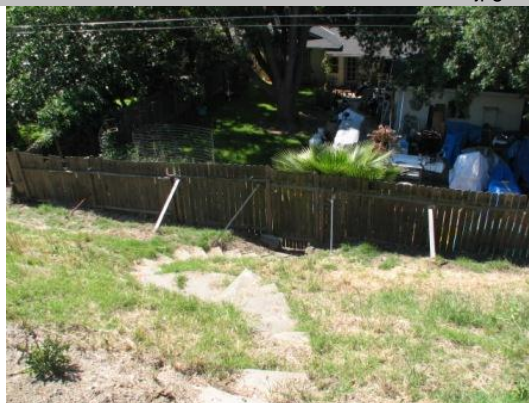
Photo 1 of 1 : mkhashch_s_20140428_00110.jpg

LM Start	4.93	Rating **	U	Issue No.	45
LM End	4.93	Issue Type +	En	Location *	LS
Category	Earthen Levee			GPS Latitude/Longitude	
				Start	End
Item	Encroachments			38.580846 °	38.580846 °
				-121.430699 °	-121.430699 °
DWR ID	DWR_NA0001_04_s _ 2012_45				
Action/Comments					
Fence Inspector Comments: Wooden fence with bracing obstructs access and visibility.

Wooden fence and braces obstruct access and visibility.

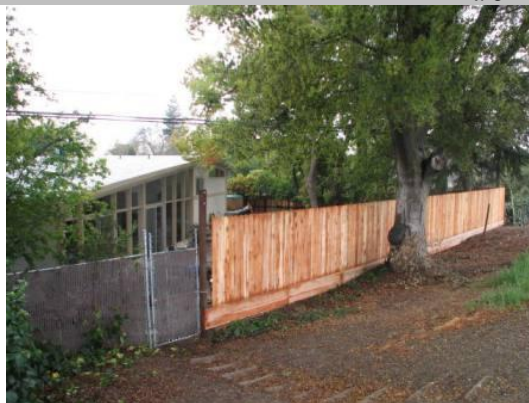
Photo 1 of 1 : mkhashch_s_20140428_00253.jpg

LM Start	5.13	Rating **	U	Issue No.	208
LM End	5.13	Issue Type +	En	Location *	LS
Category	Earthen Levee			GPS Latitude/Longitude	
				Start	End
Item	Encroachments			38.580913 °	38.580913 °
				-121.427119 °	-121.427119 °
DWR ID	DWR_NA0001_04_s _ 2012_208				
Action/Comments					
Fence					
Inspector Comments: Privacy fence and landscaping within 10-ft of the levee toe obstruct access and visibility.

03/16/2012 Wood privacy fence completely obstructs access and visibility.

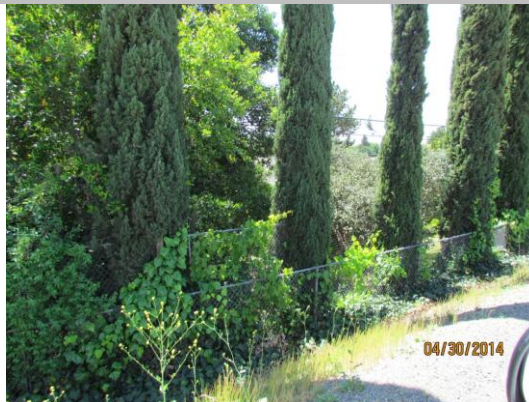
Photo 1 of 1 : mkhashch_s_20140509_00976.jpg

LM Start	5.15	Rating **	M	Issue No.	47
LM End	5.15	Issue Type +	En	Location *	LS
Category	Earthen Levee			GPS Latitude/Longitude	
				Start	End
Item	Encroachments			38.580773 °	38.580773 °
				-121.426691 °	-121.426691 °
DWR ID	DWR_NA0001_04_s _ 2012_47				
Action/Comments					
Fence					
Inspector Comments: Chain link fence, helix sky pencil, and landscaping within 10-ft of the levee toe obstruct access and visibility.

View of the fence and vegetation at the landside levee toe.

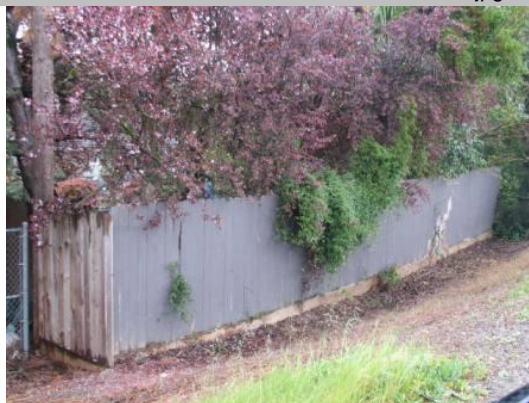
Photo 1 of 1 : mkhashch_s_20140428_00112.jpg

LM Start	5.17	Rating **	U	Issue No.	48
LM End	5.17	Issue Type +	En	Location *	LS
Category	Earthen Levee			GPS Latitude/Longitude	
				Start	End
Item	Encroachments			38.580622 °	38.580622 °
				-121.426372 °	-121.426372 °
DWR ID	DWR_NA0001_04_s _ 2012_48				
Action/Comments					
Fence Inspector Comments: Wood privacy fence and landscaping within 10-ft of the levee toe obstruct access and visibility.

03/16/2012 Wood privacy fence completely obstructs access and visibility.

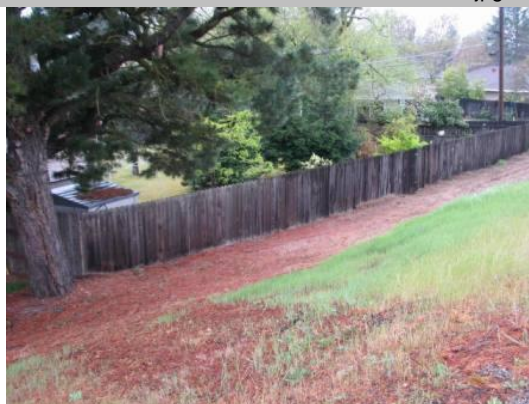
Photo 1 of 1 : mkhashch_s_20140428_00113.jpg

LM Start	5.45	Rating **	U	Issue No.	49
LM End	5.45	Issue Type +	En	Location *	LS
Category	Earthen Levee			GPS Latitude/Longitude	
				Start	End
Item	Encroachments			38.577589 °	38.577589 °
				-121.423350 °	-121.423350 °
DWR ID	DWR_NA0001_04_s _ 2012_49				
Action/Comments					
Fence					
Inspector Comments: Wood privacy fence within 10-ft of the levee toe obstruct access and visibility.

03/16/2012 Wood privacy fence completely obstructs access and visibility.

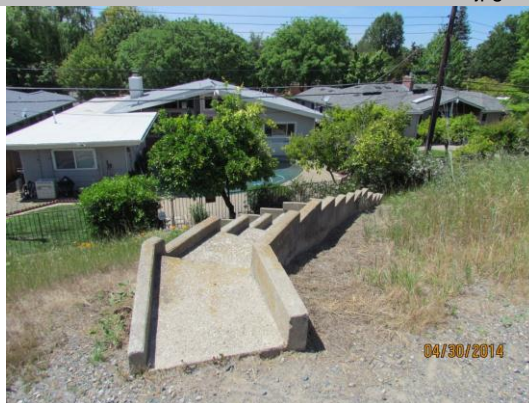
Photo 1 of 1 : mkhashch_s_20140509_00975.jpg

LM Start	5.57	Rating **	U	Issue No.	197
LM End	5.57	Issue Type +	En	Location *	LS
Category	Earthen Levee			GPS Latitude/Longitude	
				Start	End
Item	Encroachments			38.575887 °	38.575887 °
				-121.423113 °	-121.423113 °
DWR ID	DWR_NA0001_04_s_2013_197				
Action/Comments					
Stairway Inspector Comments: Unpermitted stairs to be removed by ARFCD.

View of the stairs on the landside levee slope.

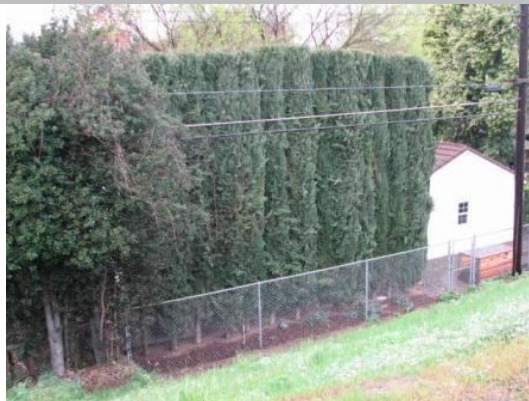
Photo 1 of 1 : mkhashch_s_20140428_00115.jpg

LM Start	5.61	Rating **	U	Issue No.	52
LM End	5.61	Issue Type +	En	Location *	LS
Category	Earthen Levee			GPS Latitude/Longitude	
				Start	End
Item	Vegetation			38.575379 °	38.575379 °
				-121.423201 °	-121.423201 °
DWR ID	DWR_NA0001_04_s_2012_52				
Action/Comments					
Landscaping Inspector Comments: Helix sky pencil trees within 10-ft of the levee toe obstruct visibility and access.

03/16/2012 Landscaping obstructs visibility and access.

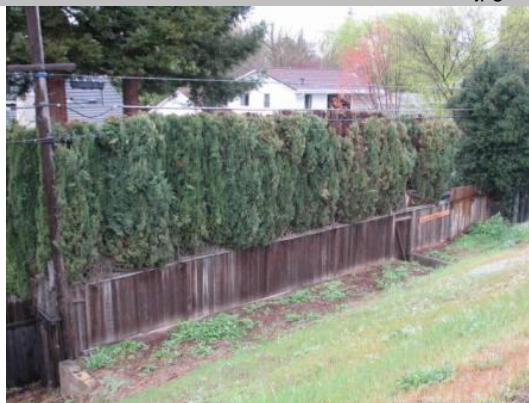
Photo 1 of 1 : mkhashch_s_20140428_00116.jpg

LM Start	5.63	Rating **	U	Issue No.	53
LM End	5.63	Issue Type +	En	Location *	LS
Category	Earthen Levee			GPS Latitude/Longitude	
				Start	End
Item	Vegetation			38.575250 °	38.575250 °
				-121.423240 °	-121.423240 °
DWR ID	DWR_NA0001_04_s _ 2012_53				
Action/Comments					
Landscaping Inspector Comments: Wood privacy fence, helix sky pencil, vines and landscaping within 10-ft of the levee toe obstruct access and visibility. Cement stairs up levee slope.

03/16/2012 Landscaping and fence obstruct visibility and access.

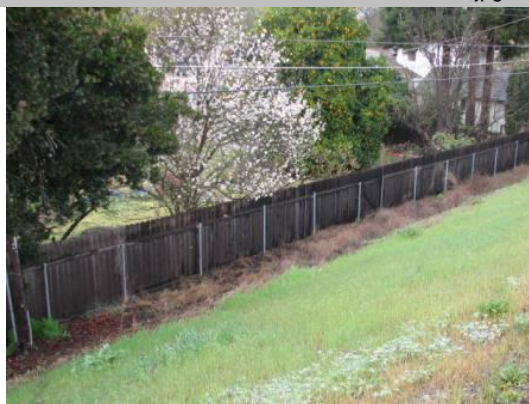
Photo 1 of 1 : mkhashch_s_20140428_00117.jpg

LM Start	5.64	Rating **	U	Issue No.	54
LM End	5.64	Issue Type +	En	Location *	LS
Category	Earthen Levee			GPS Latitude/Longitude	
				Start	End
Item	Encroachments			38.575093 °	38.575093 °
				-121.423263 °	-121.423263 °
DWR ID	DWR_NA0001_04_s _ 2012_54				
Action/Comments					
Fence Inspector Comments: Wood privacy fence and landscaping within 10-ft of the levee toe obstruct access and visibility.

03/16/2012 Wood privacy fence completely obstructs access and visibility.

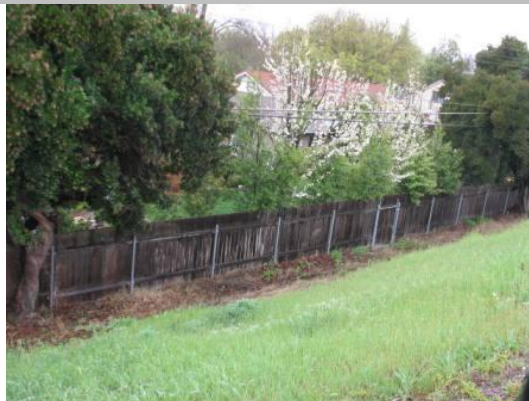
Photo 1 of 1 : mkhashch_s_20140428_00118.jpg

LM Start	5.66	Rating **	U	Issue No.	55
LM End	5.66	Issue Type +	En	Location *	LS
Category	Earthen Levee			GPS Latitude/Longitude	
				Start	End
Item	Encroachments			38.574837 °	38.574837 °
				-121.423297 °	-121.423297 °
DWR ID	DWR_NA0001_04_s _ 2012_55				
Action/Comments					
Fence					
Inspector Comments: Wood privacy fence within 10-ft of the levee toe obstructs visibility.

03/16/2012 Wood privacy fence completely obstructs access and visibility.

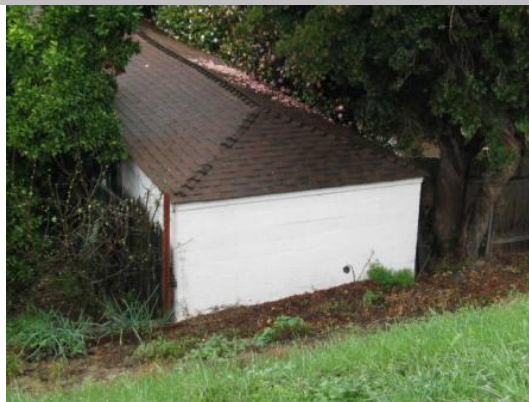
Photo 1 of 1 : mkhashch_s_20140428_00119.jpg

LM Start	5.67	Rating **	U	Issue No.	56
LM End	5.67	Issue Type +	En	Location *	LS
Category	Earthen Levee			GPS Latitude/Longitude	
				Start	End
Item	Encroachments			38.574648 °	38.574648 °
				-121.423348 °	-121.423348 °
DWR ID	DWR_NA0001_04_s _ 2012_56				
Action/Comments					
Building Inspector Comments: Cement block building on levee slope obstructs access.

03/16/2012 Structure within 15' of levee toe.

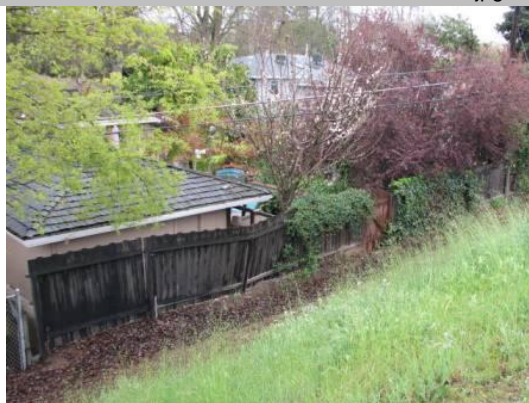
Photo 1 of 1 : mkhashch_s_20140428_00120.jpg

LM Start	5.72	Rating **	U	Issue No.	57
LM End	5.72	Issue Type +	En	Location *	LS
Category	Earthen Levee			GPS Latitude/Longitude	
				Start	End
Item	Encroachments			38.573927 °	38.573927 °
				-121.423480 °	-121.423480 °
DWR ID	DWR_NA0001_04_s _ 2012_57				
Action/Comments					
Fence					
Inspector Comments: Wood privacy fence with ivy obstructs visibility.

03/16/2012 Wood privacy fence completely obstructs access and visibility.

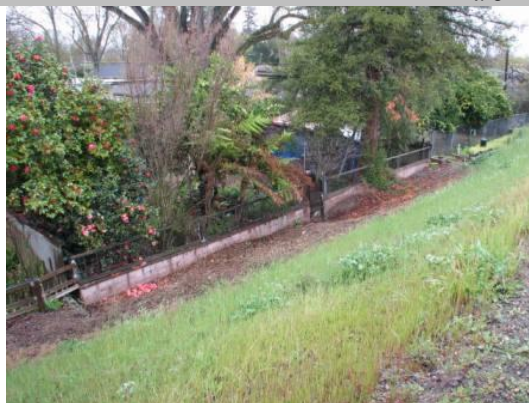
Photo 1 of 1 : mkhashch_s_20140428_00121.jpg

LM Start	5.76	Rating **	U	Issue No.	59
LM End	5.76	Issue Type +	En	Location *	LS
Category	Earthen Levee			GPS Latitude/Longitude	
				Start	End
Item	Encroachments			38.573403 °	38.573403 °
				-121.423642 °	-121.423642 °
DWR ID	DWR_NA0001_04_s _ 2012_59				
Action/Comments					
Fence					
Inspector Comments: Brick fence and landscaping within 10-ft of the levee toe obstructs access and visibility.

03/16/2012 Fence and landscaping obstruct visibility and access.
